**A. BOARD OF ARCHITECTURAL REVIEW APPLICATION FOR THE APPROVAL OF A TREE REMOVAL AND REPLACEMENT PLAN AND RE-VEGETATION PLAN FOR THE PURE WATER MONTEREY GROUNDWATER REPLENISHMENT PROJECT AND PRODUCT WATER CONVEYANCE FACILITIES. AN ENVIRONMENTAL IMPACT REPORT HAS BEEN PREPARED FOR THE PROJECT.**

**PURPOSE & RECOMMENDATION:** In accordance with the Mitigation and Monitoring Reporting Program, Board of Architectural Review approval is required for a tree replacement plan and re-vegetation plan for the RUWAP project biotic disturbances within the City of Seaside.

## Approximate Proposed Alignment and Limits of Construction

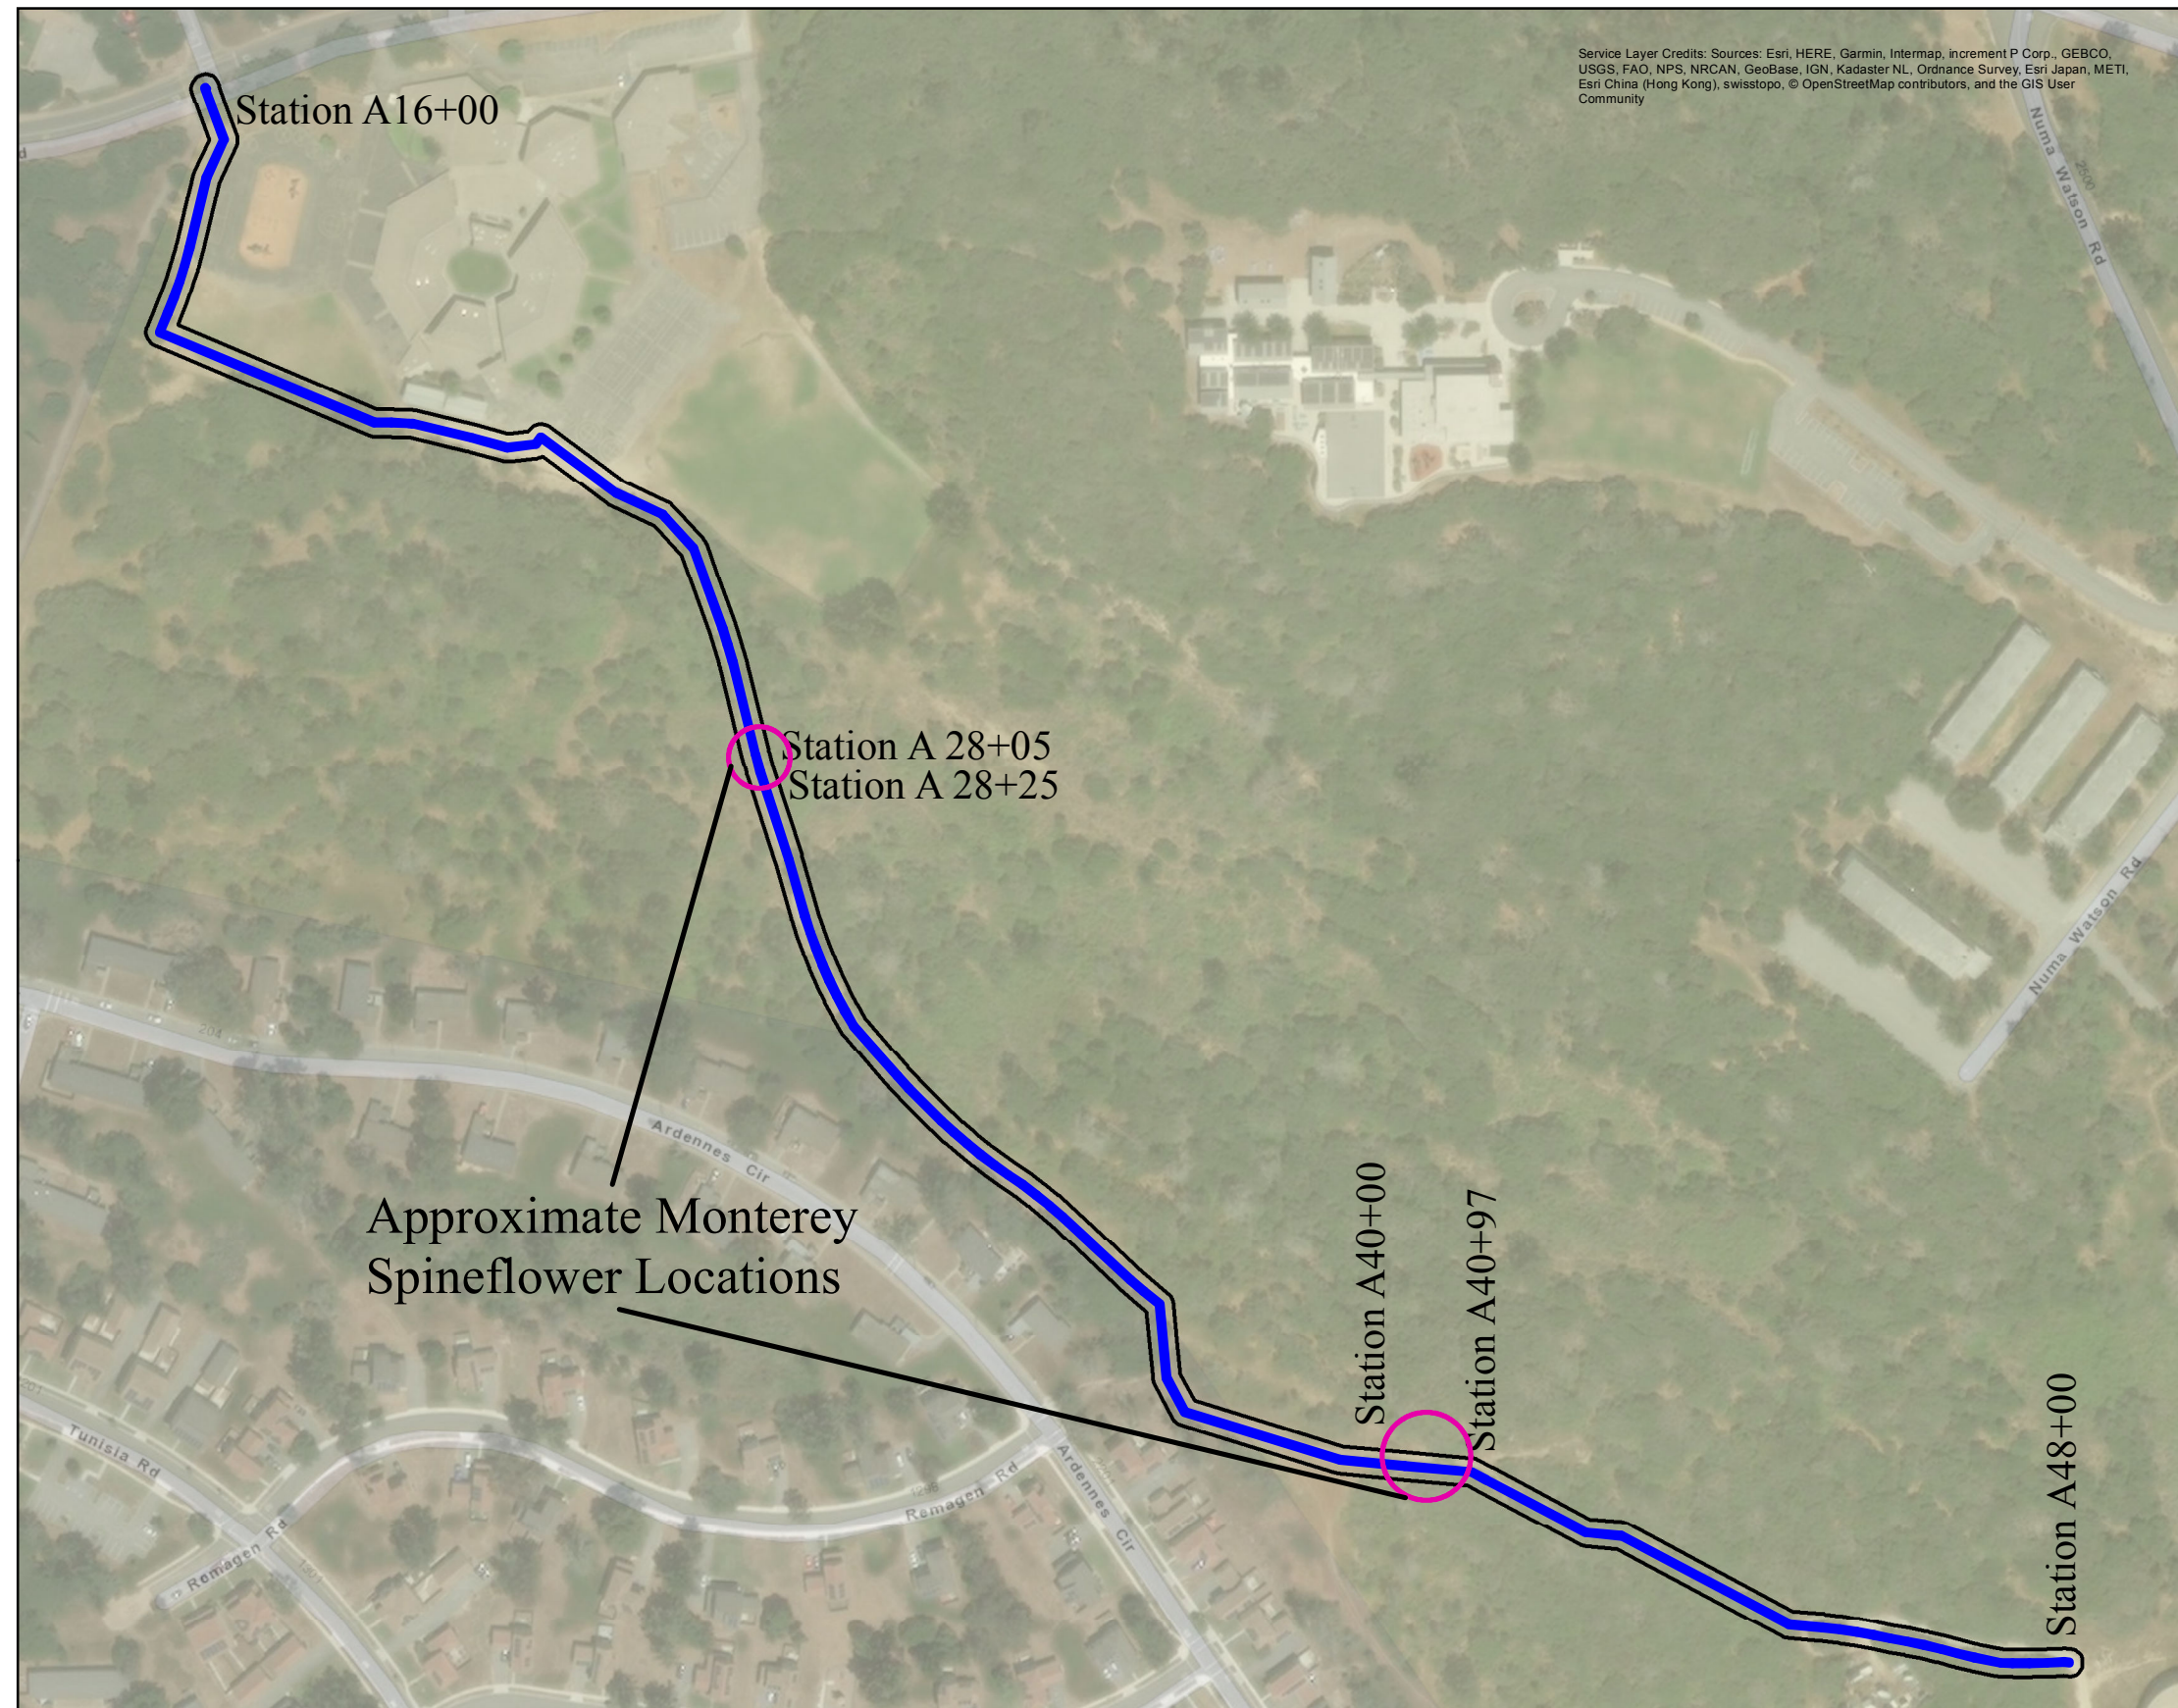
Figure  
 2

— Centerline Station A16+00-  
 □ Approximate Limits of Construction

## Special-Status Plant Species Locations

A review of the historical data for this section of the proposed alignment shows no known populations of special-status plant species within or adjacent to the proposed alignment from station A16+00 to A48+00 (Figure 2). Surveys prior to the onset of construction were conducted April 27, May 18, and May 30, 2018. During the survey effort three polygons of Monterey spineflower (*Chorizanthe pungens* var. *pungens*) were observed at stations A28+05, A28+25, and from approximately station A40+00 to A40+97. DD&A marked the extents of each polygon with orange ground-marking paint.

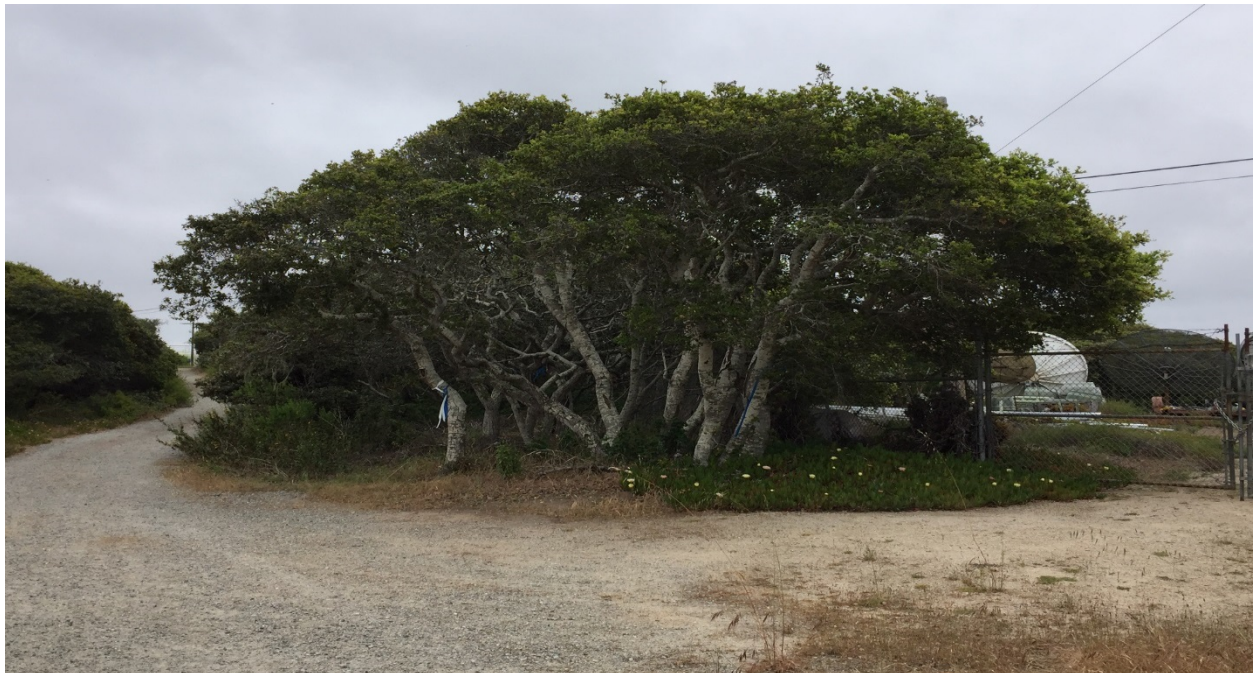
**Image #1 – coast live oaks (Station 46 + 42) – typical size and grove density of upper section.**

The property, a utility easement and adjacent lands is an approximately one-half mile strip, beginning at engineer's station 48 + 33 and ending at station 26 + 03, above a public school. The upper section is primarily composed of undeveloped, dense, low growing, coast live oak woodland (Image #1). In the middle section adjacent to Ardennes Circle, the tree density thins out and the tree size increases. In the lower section most of the trees are young coast live oaks located immediately adjacent to a road cut. A few mature Monterey pines and live oaks are located further off the road cut. The topography ranges from flat to gently sloping to steeply sloping. located further off the road cut. The topography ranges from flat to gently sloping to steeply sloping.
